Working of Suburban Section with overaged Infrastructure of Sealdah Division

Experiences & Innovations

Working of suburban section with over-aged infrastructure - Experience and Innovations.

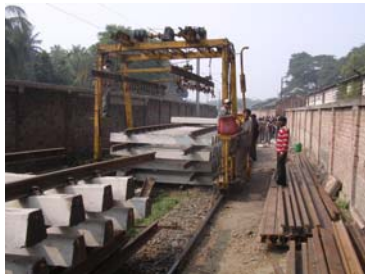
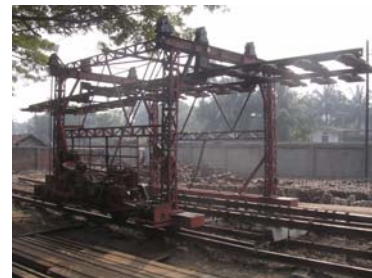
(iii) **Kinds of Portals:** There are two kinds portals Hydraulically and Mechanically operated. Both have been found satisfactory.

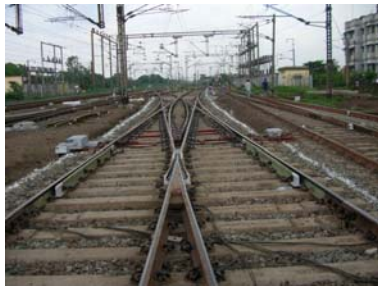
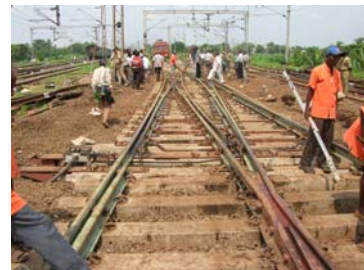
3.2.1 Sealdah division is having more than 56 nos. of diamond crossings and renewal is taking time for want of supply of materials. 2 nos. of diamonds have been replaced with concrete sleepers in DDJ yard.

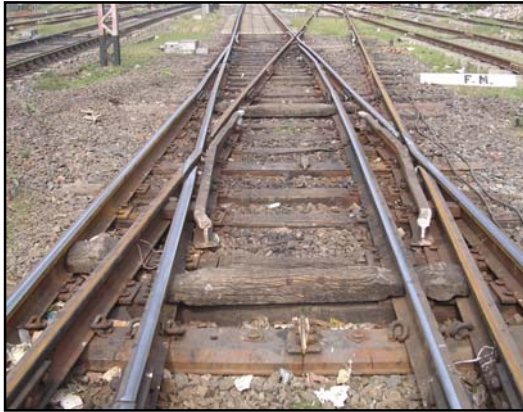
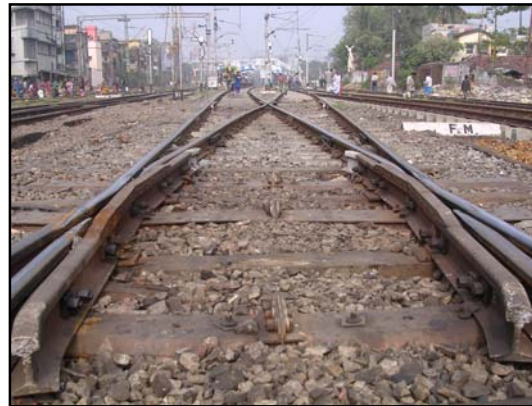
Due to increase in no. of speed restriction and non-availability of wooden sleepers the division has developed a special kind of arrangement for maintaining the diamond crossing for track circuited as well as non-track circuited area. For the track circuited area steel casing of the old points and crossings sleepers were used as pad plate for

(Photo showing insulating casing for better maintenance of Diamonds)

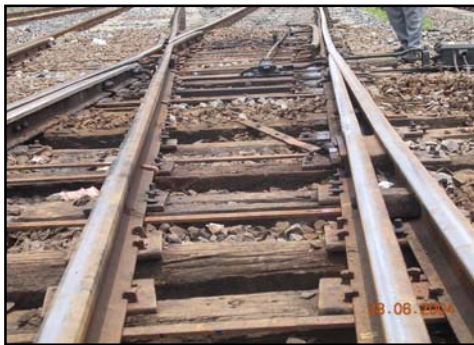
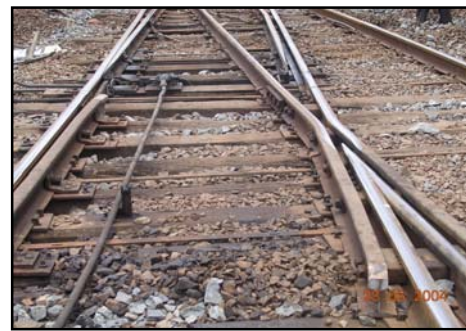
provision of insulation, where as for the non-track Circuiting area simply bent tie-bars were used for holding of gauge.

(Photo showing bend tie bars for better maintenance of Diamonds)

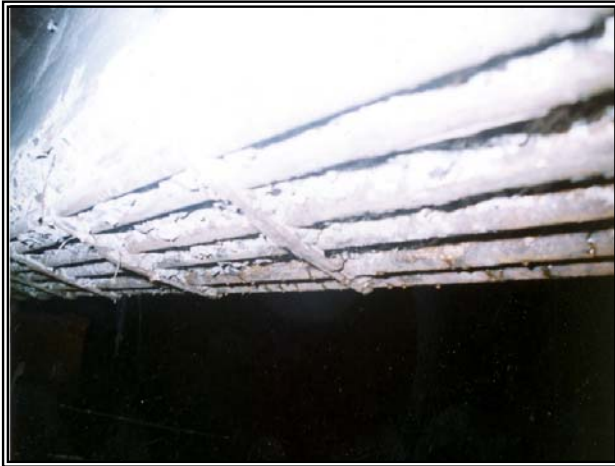
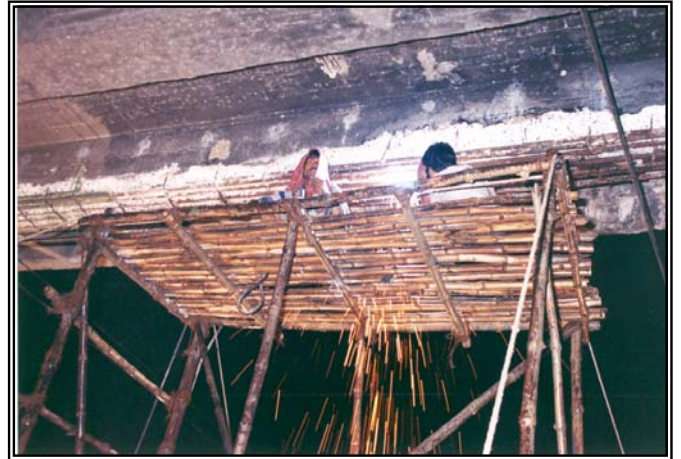
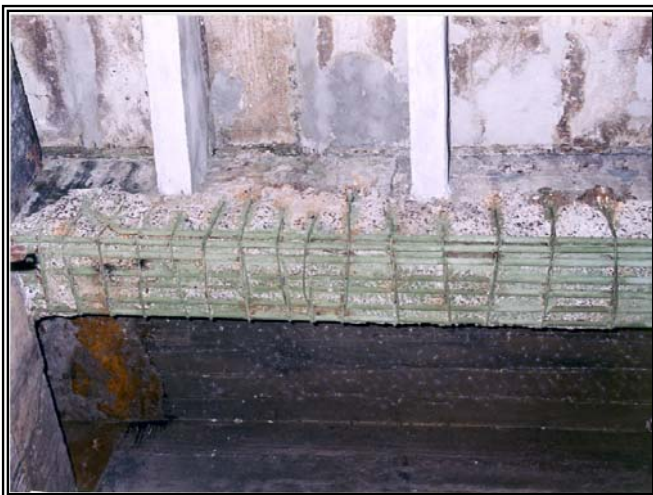
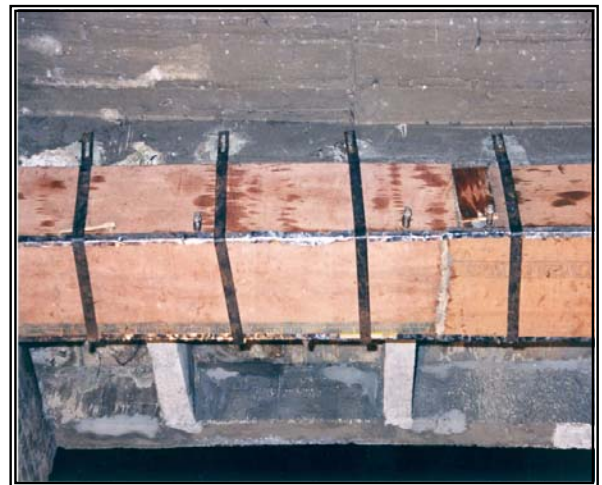
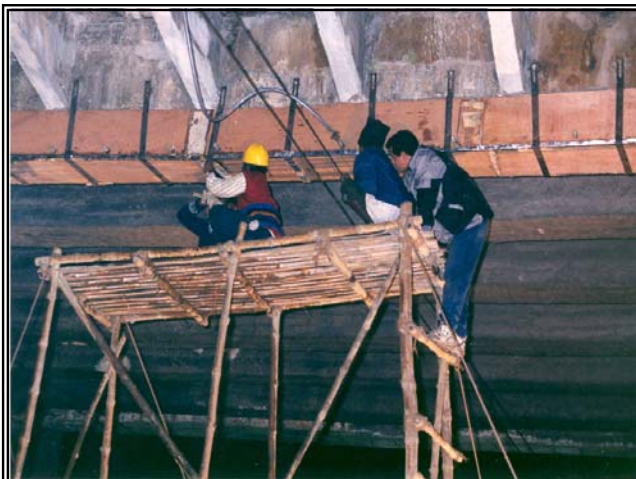
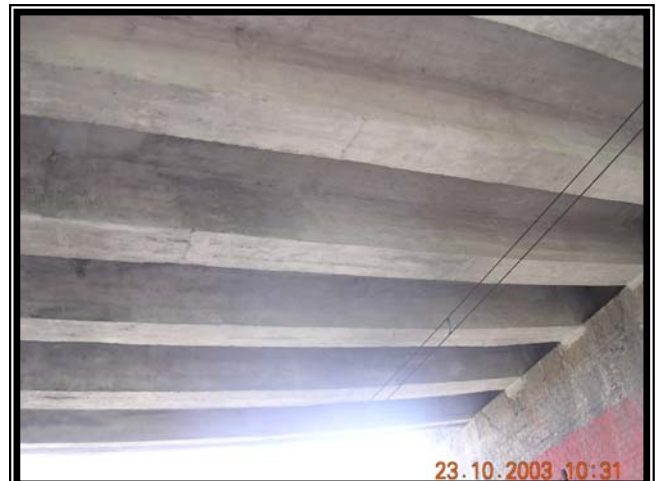
3.3.8 Sequences of heavy repairs under taken is as under:

- i) During the hollowness test it was found that only the two end beams are badly affected and major reinforcement were exposed and damaged due to corrosion to the maximum extent.
- ii) The cantilever beams supporting the footpath were also damaged and reinforcement in some locations of deck slabs were totally and exposed.
- iii) It was found during the inspection that some patch repairing work with EPOXY MOTAR was done at site but cavity remained in the end beams.
- iv) The cover concrete at bottom centre of end beams spalled & fell down. The reinforcement at the bottom were exposed

& corroded. The diameter reduced to 30 to 40% in some of the rods as seen to the bars already exposed.

- v) Cavities were noticed in the end beams & cantilever footpath beams.
- vi) In several areas of deck concrete, signs of reinforcement corrosion was observed along with de-lamination of cover concrete.
- vii) It was apprehended the strength of the affected beams were reduced considerably & required strengthening. Any further deterioration of the structure could cause collapse of the structure causing fatal consequences on safety of road traffic, train services and passengers both on the road and train.

- a) Remove damage concrete & wash thoroughly to make free from all loose particles.
- b) Repair reinforcing rods & strengthen the reinforcement by putting additional rods by welding.
- c) Repair of big cavities in RCC T Beam having congestion of reinforcement bars by pumping Non-shrink free flow by grouting with high strength cementitious grout.
- d) For strengthening the T Beams, additional external reinforcement shall be provided to increase the load bearing capacity. Such external reinforcement will be provided by laminating Carbon Fibre Reinforce Plastic (CFRP).
- e) Carry out patch repair to the delaminated deck & beams by using protective coating to the rebars.
- f) To enhance durability of the structure apply protective & water proofing coating to all concrete surface.

The condition of the ROB no. 29 was such that the replacement of the structure was only solution. This solution was not practical as this would have necessitated closure of the road & block of the railway line passing below. Moreover the cost of complete rebuilding was Rs.1.4 Crores against which only Rs.12.7 lakh was paid. The repair & strengthening was to be done in situ under traffic by taking designed block of track during the night. The big cavities in RCC beam were repaired & Sika Carbodour laminates were pasted.
